Manhole Inspection Summary

Manhole # S2701_003MH

Location Address: **2800 Sethlow Rd. (cherry hill maintenance office)**

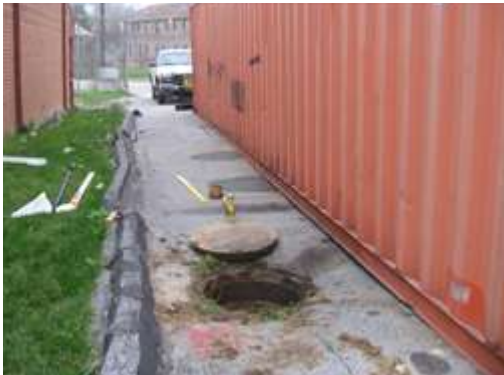
Location View

Cherry Hill Maintenance Office

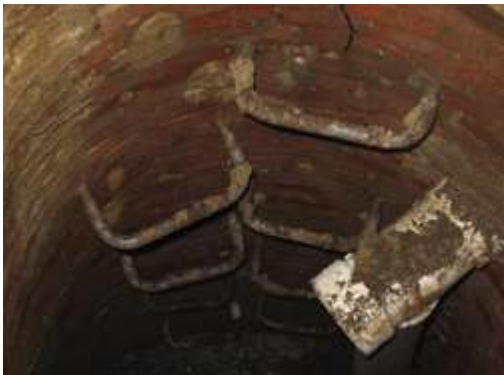
Steps Count: **8** Missing: **0** ☒ Corroded

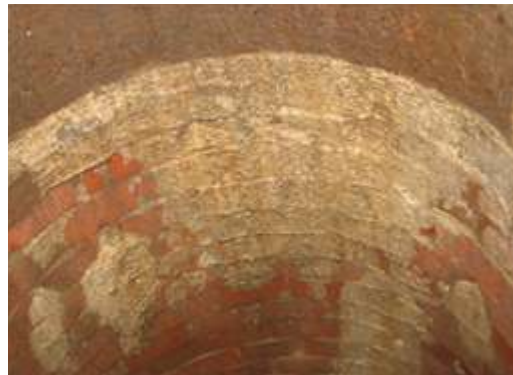
Defect 1

Infiltration: ☐ None ☐ Joint ☐ Cracks ☒ Mortar ☒ Roots ☐ Wall

Infiltration

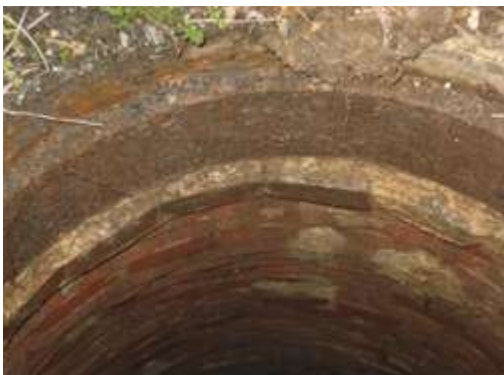
Defect 2

Frame Offset: **1** (in.) Condition: ☒ Sound ☐ Cracked ☐ Leaks

Frame offset

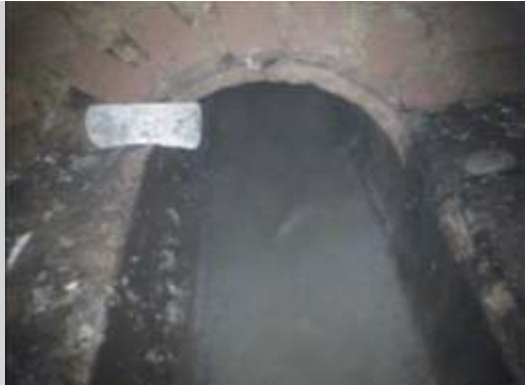
12 O'Clock Outflow

12 in. Circular Gravity Sewer
Pipe Out @ 12 O'Clock

Pipe Height: **12** (in.) Rod and Bar (Angled)
Pipe Material: **Clay** ☐ Pipe Lined
Invert Depth: **14.92** (ft.) Flow Characteristics: **Fast**
Deposits: ☒ None ☐ Mud ☐ Sludge ☐ Debris ☐ Grease
Silt Depth: (in.) Deposits Extent:
Infiltration: **None** Pipe Seal Cond: **Sound**

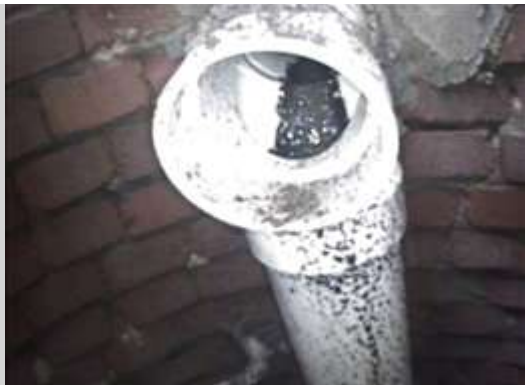
5 O'Clock Inflow

6 in. Circular Service Sewer
Pipe In @ 5 O'Clock

Pipe Height: **6** (in.) Rod and Bar (Angled)
Pipe Material: **PVC** ☐ Pipe Lined
Invert Depth: **3.02** (ft.) Flow Characteristics: **None**
Deposits: ☒ None ☐ Mud ☐ Sludge ☐ Debris ☐ Grease
Silt Depth: (in.) Deposits Extent:
Infiltration: **None** Pipe Seal Cond: **Sound**

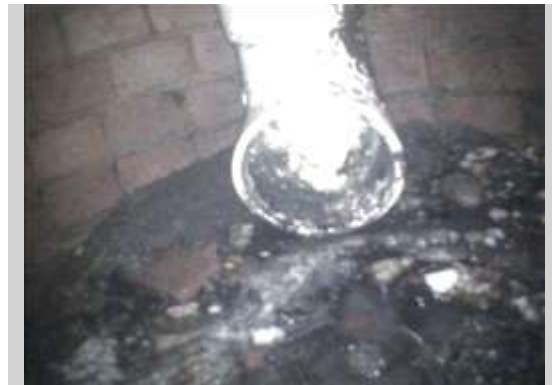
Drop In @ 5 O'Clock

Drop: **Inside** Rod and Bar
Angled: **Yes** Reading: **13.02** (ft.)
Inv Depth: **14.02** (ft.)
Drop Condition: **Open**

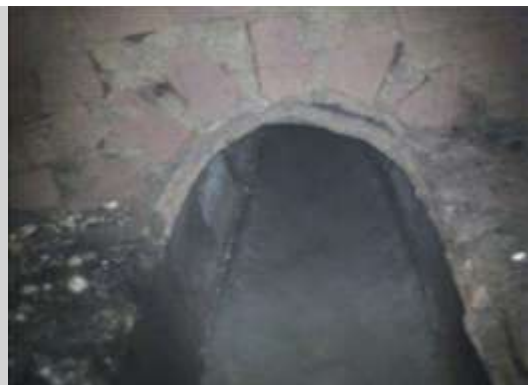
6 O'Clock Inflow

12 in. Circular Gravity Sewer
Pipe In @ 6 O'Clock

Invert Depth: **15.04** (ft.) Flow Characteristics: **Fast**

Infiltration: **None** Pipe Seal Cond: **Sound**
